Channel Stability Problems, Iao Stream, Maui, Hawaii

**U.S. Army Engineer Committee on Channel Stabilization
Report of the 64th Meeting—September 1999**

ERDC/CHL SR-00-2
CCS-00-2
June 2000

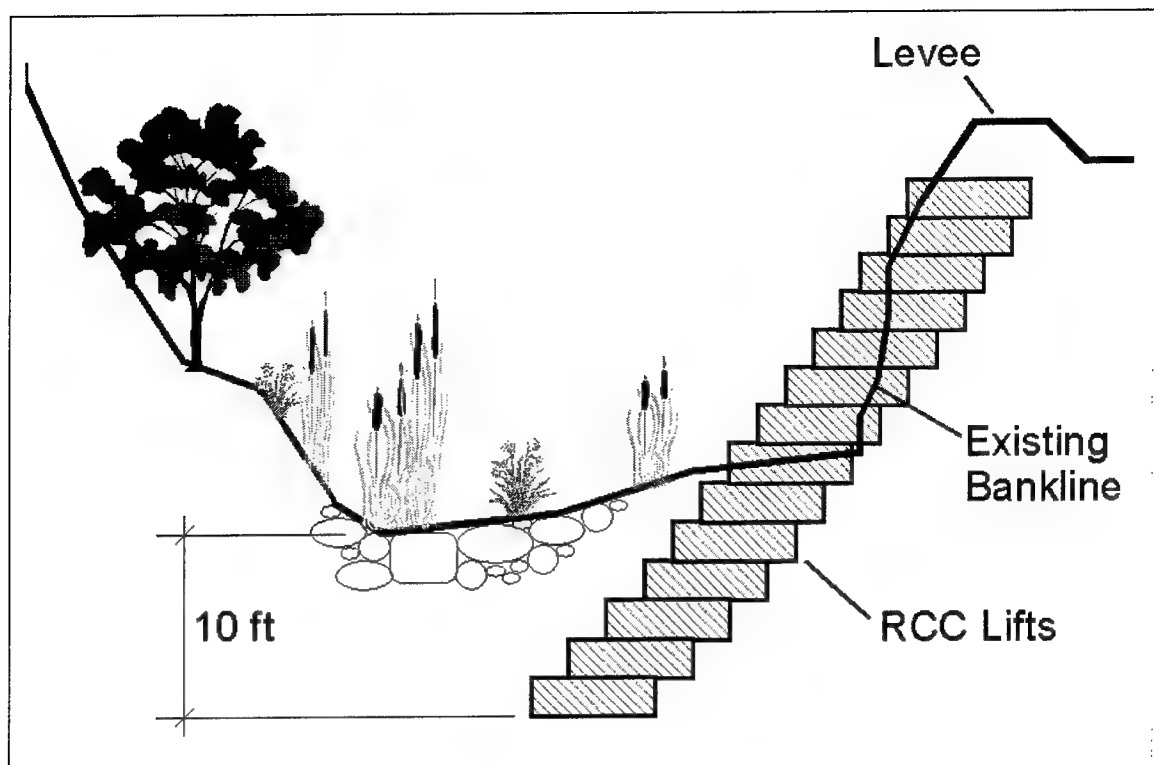
Figure 8. Bank protection alternative near Sta 43+00

Bank protection at Sta 43+00. During the field trip, one of the more spectacular sights included the eroding bank near Sta 43+00. It appears that the sideslope of the right levee (Levee B) has eroded by as much as about 15 to 20 ft (or more) horizontally. I would recommend that POH give this reach top priority since failure of the levee is imminent. I envision that the roller-compacted concrete (RCC) sideslope discussed for the channel alternative be constructed along the right bank as soon as possible along this critical reach (Figure 7). Future construction of the channel could be designed to tie into this "early-built" section as necessary. Perhaps, the RCC sideslope could be constructed a minimum of 10 ft below the existing thalweg to prevent undermining, at least for the next few years, while at the same time providing immediate bank protection along this reach. I recommend EM 1110-2-2006 "Roller-compacted concrete" (1992) as a reference for RCC design and placement.

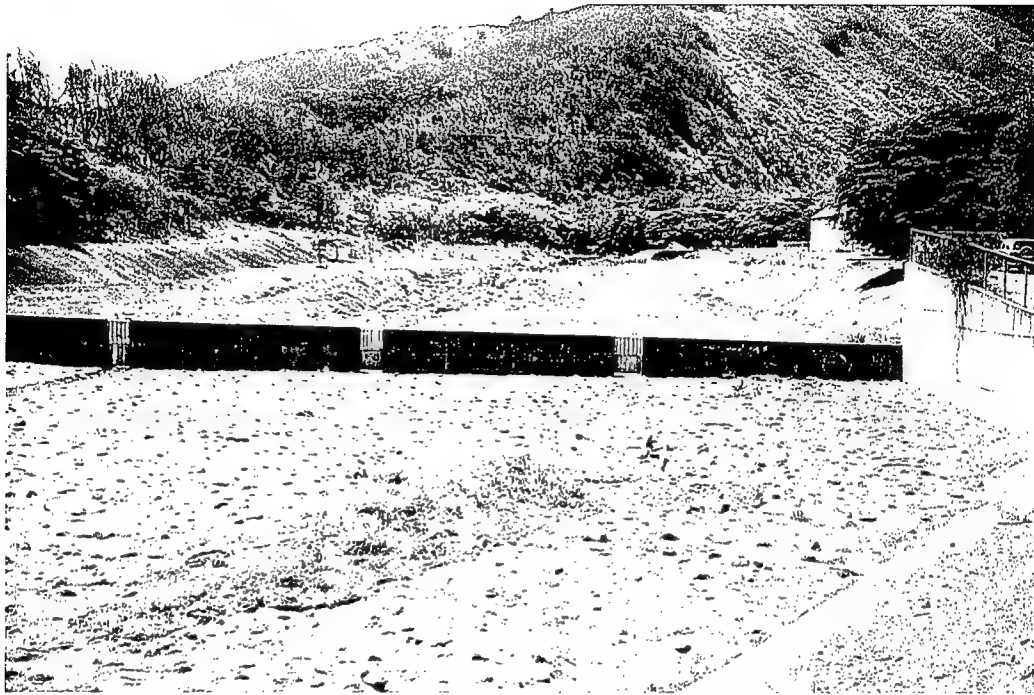
Photo 1. Sediment basin (Sta 127+00) upstream end of Lao Stream Project

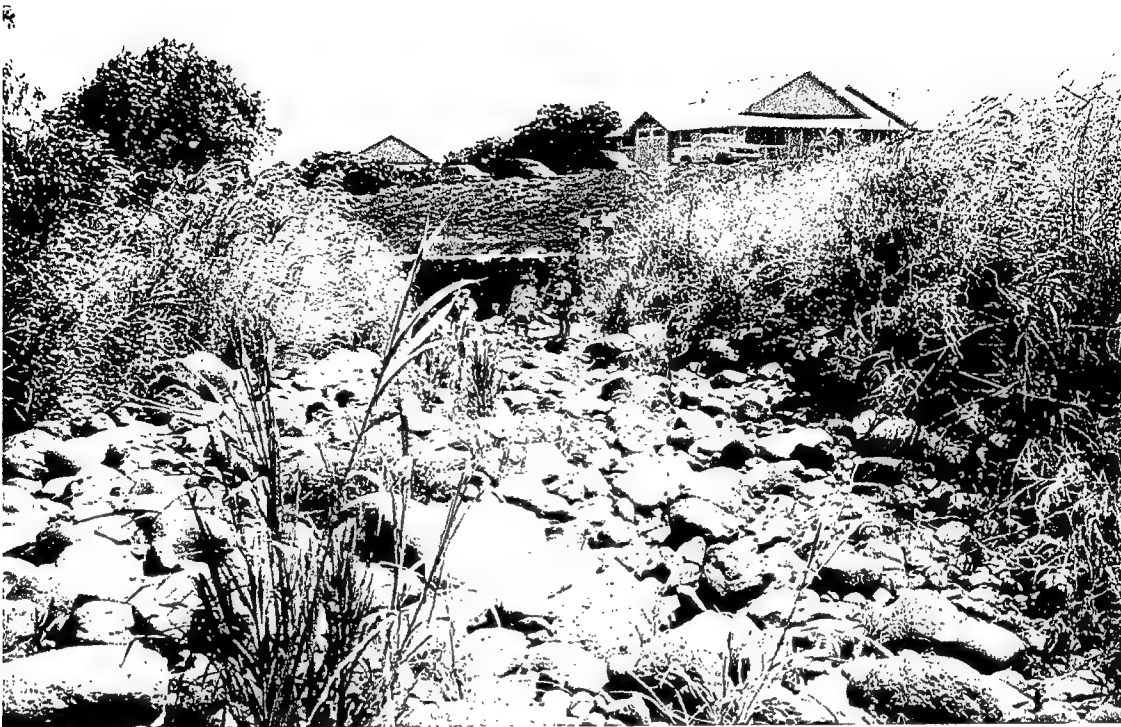
Photo 3. Channel impingement at Sta 50+00

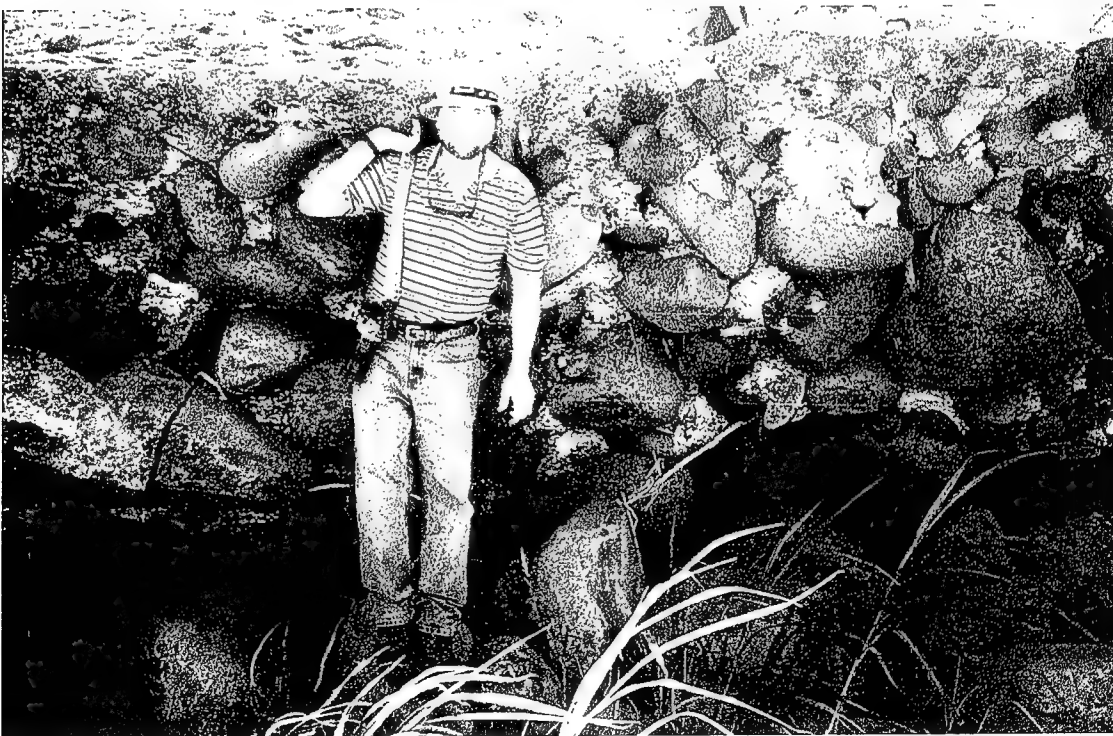
Photo 4. Local scour under grouted stone apron Sta 41+00 to 49+00

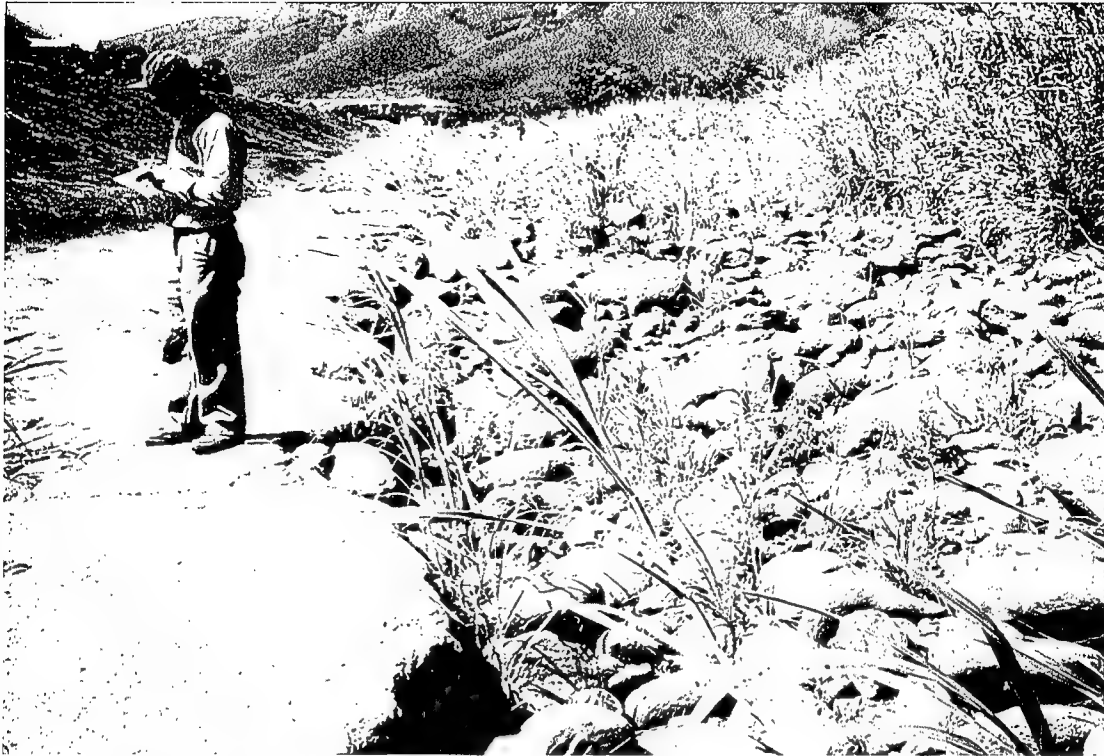
Photo 5. Toe apron Sta 41+00 to 49+00

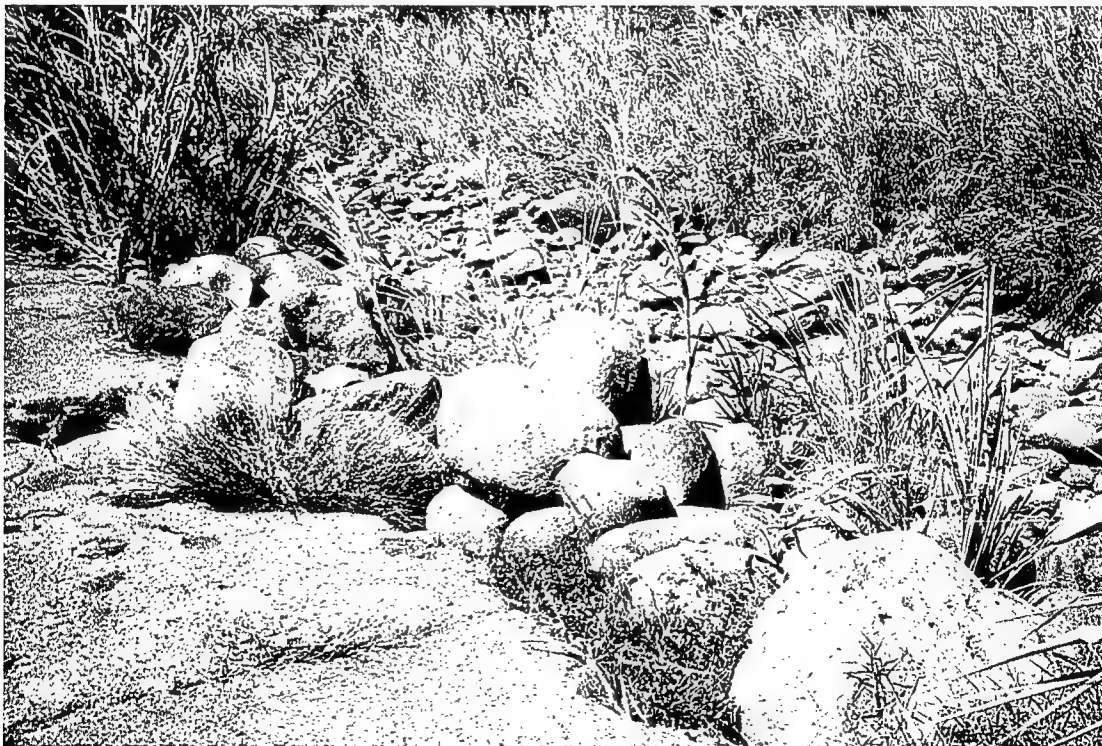
Photo 6. Repair to toe apron – Sta 41+00 to 49+00

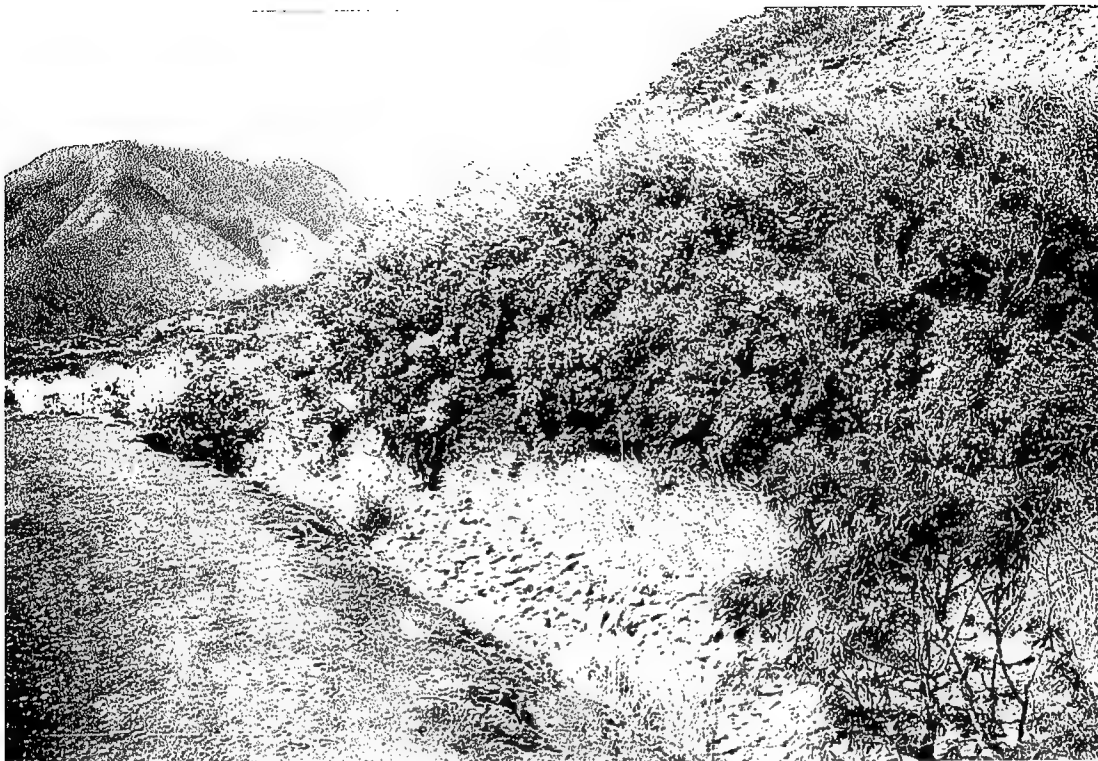
Though the approach utilized by the District for evaluating levee failure was appropriate for the economic assessment, I would expect the levee with the vertical bank near Sta 40+00 to be the first to fail given the existing conditions. Unfortunately, I didn't mark my maps and don't recall if this was the upper portion of Levee A or the downstream end of Levee B. Either way, this reach is in critical condition and in immediate need of repair.

Photo 7. Constriction at Sta 40+00

The first order of business must be the restoration of the levee integrity. This should be done within the context of the overall improvement plan, but damaged areas must be repaired quickly. I would suggest immediate repairs to the levee section near Sta 39+00 or 40+00.

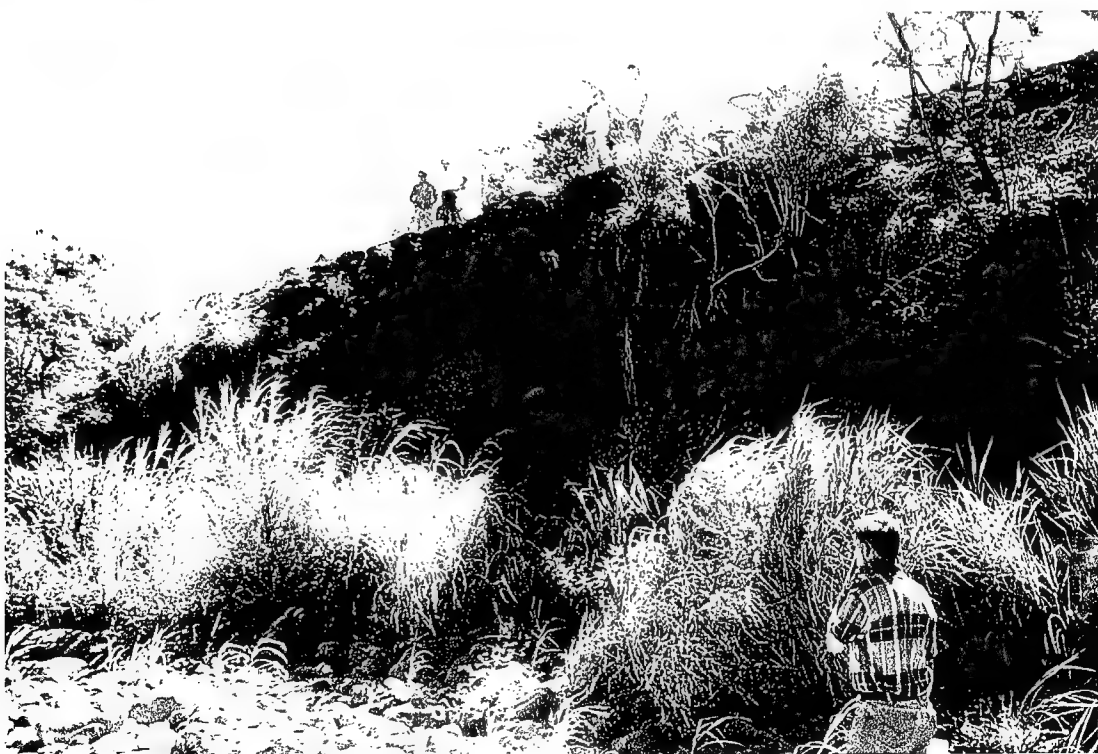
Photo 8. Bank oversteepening due to toe erosion at Sta 40+00

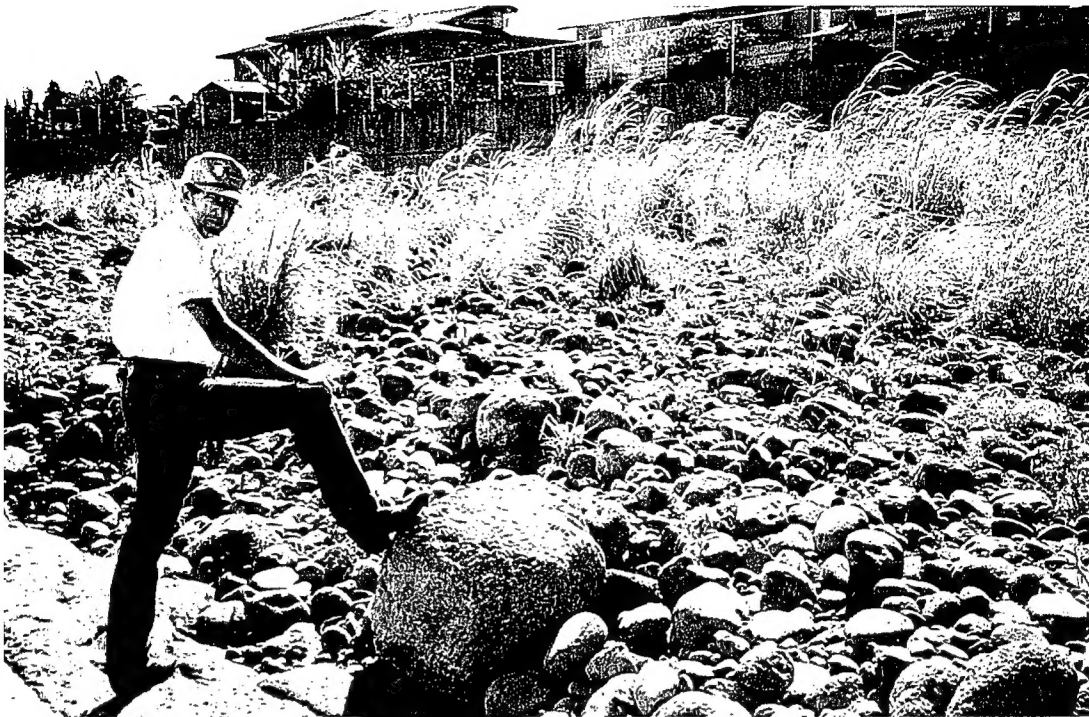
Photo 9. Deposition in boulder-concrete channel downstream from Waiehu Beach Road
